CASE STUDIES WITH JUTE GEOTEXTILES (JGT)

NATIONAL JUTE BOARD

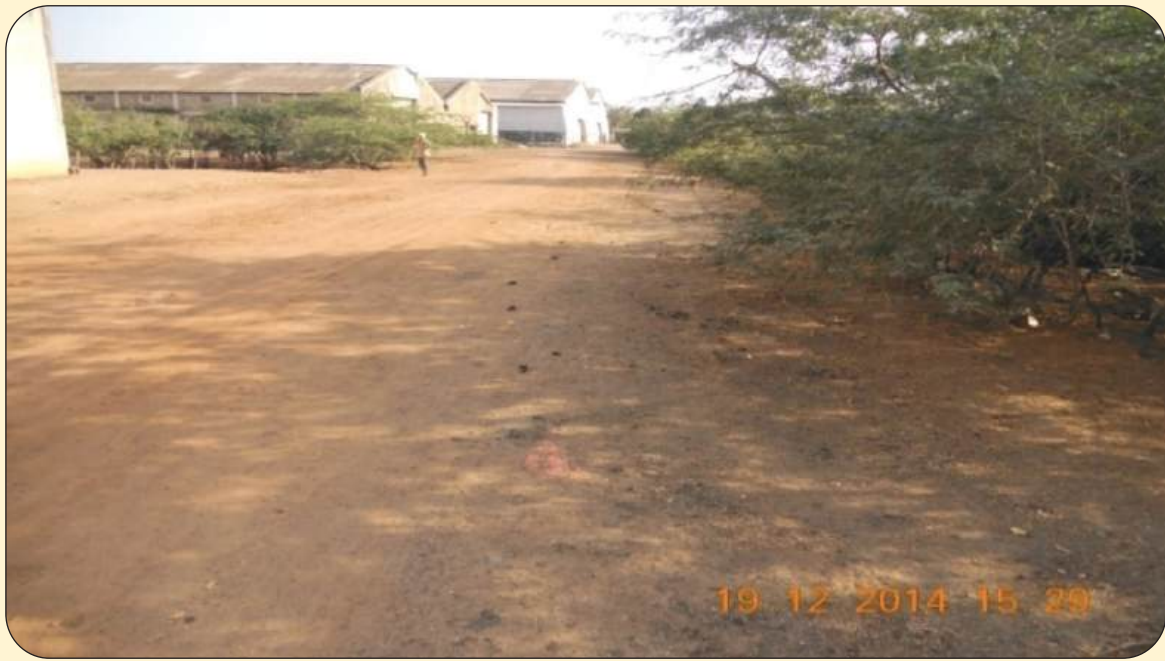
Unpaved road is in good condition with no noticeable distress on surface even after 17 years of construction

VIEW OF CONDITION OF ROAD AFTER 17 YEARS (2014)

(e) It may be mentioned that the stabilized road section was unaffected by the severe cyclone of 6th Nov 1996 in which Kakinada was devastated and the roads in other areas of port were badly damaged.

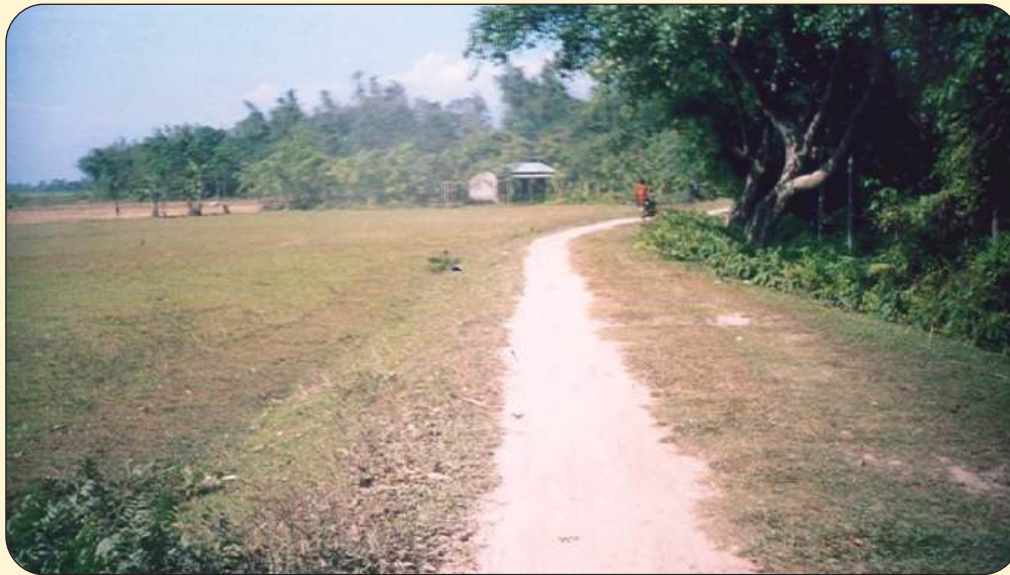
VIEW OF CONDITION OF ROAD BEFORE CONSTRUCTION

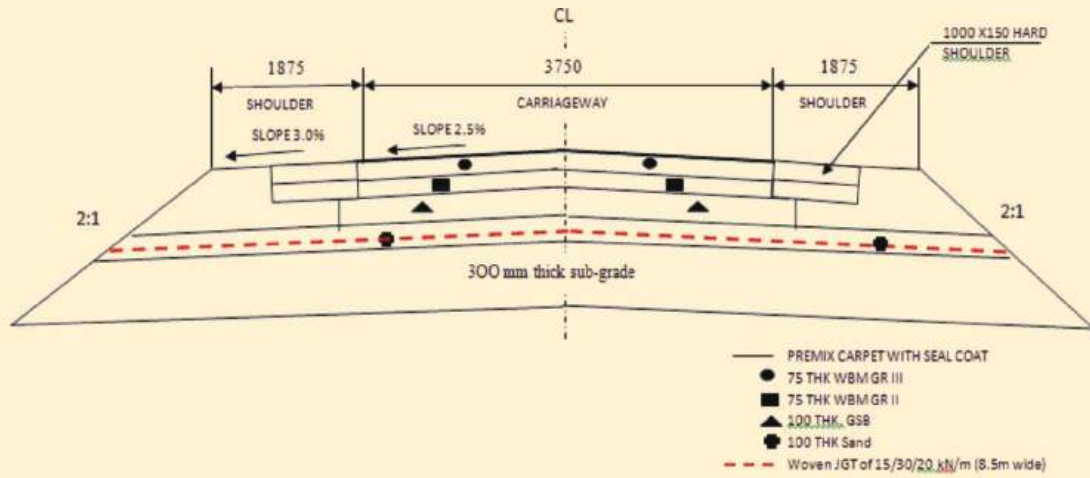
CROSS-SECTIONAL DETAILS OF PAVEMENT WITH JUTE GEOTEXTILE

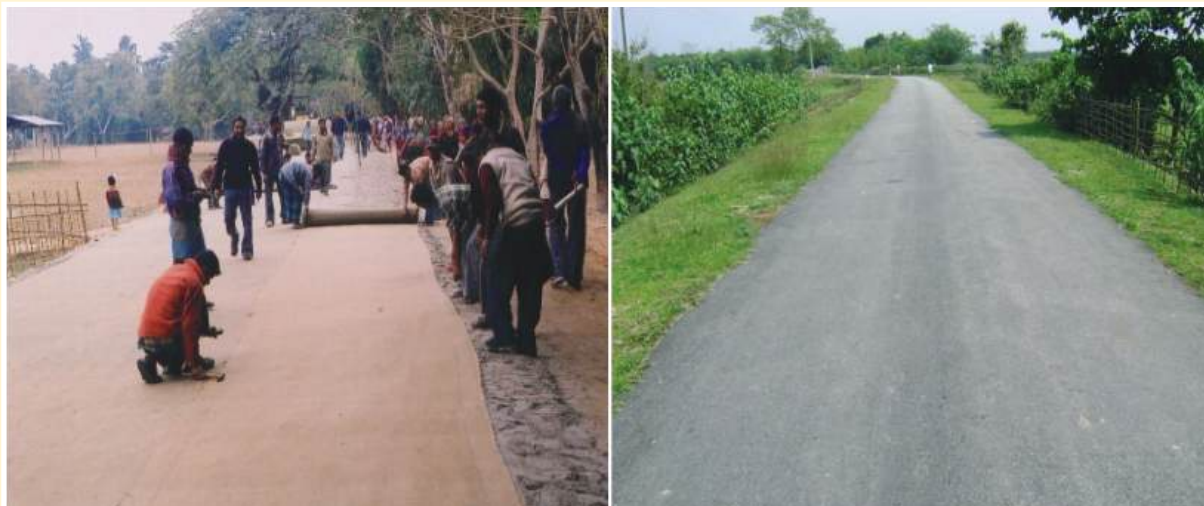
- The blacktop of pavement surface was distress-free during the entire period of performance monitoring.
- Shoulders as well as side slope condition was good without any rain-cuts or settlement with the use of Open Weave JGT at the slope.

VIEW DURING LAYING OF JGT & FINISHED CONDITION ROAD AFTER 23 MONTHS

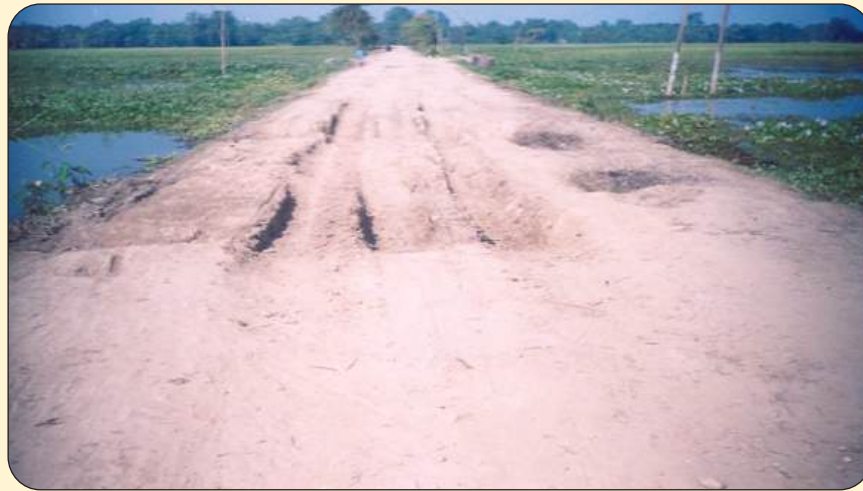
This was an earthen road under PMGSY Pilot Project. Flash flooding of the area does occur occasionally. Deep ruts had formed at some locations. Average annual rainfall of 1500 – 1600 mm observed in the area. The water table is 3 to 4 m below GL during summer and 2 to 3 m during monsoon.

VIEW OF DISTRESSED CONDITION OF ROAD BEFORE CONSTRUCTION

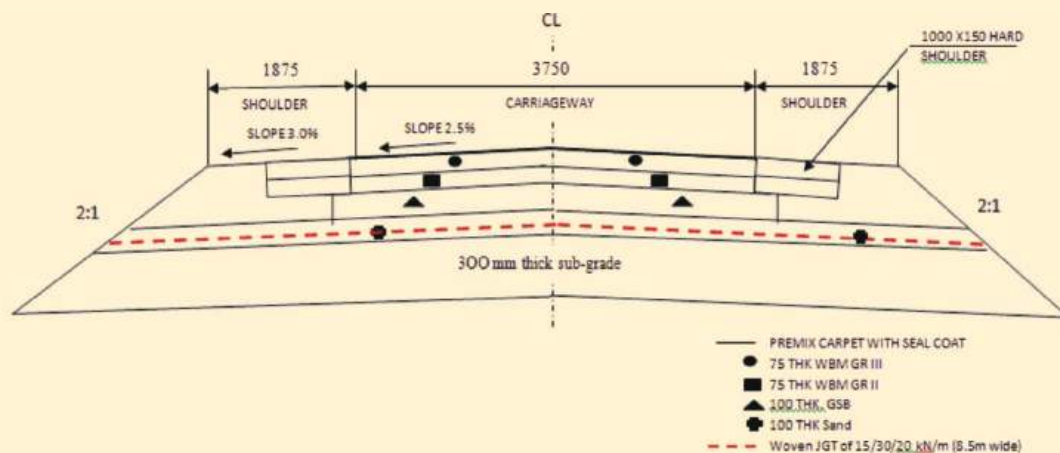
CROSS-SECTIONAL DETAILS OF PAVEMENT WITH JUTE GEOTEXTILE

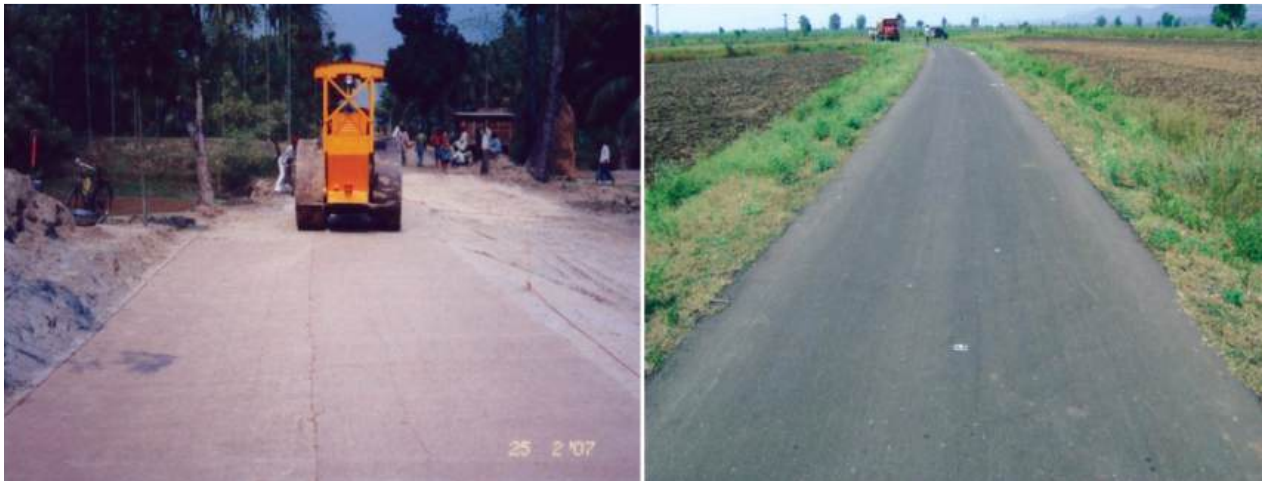
VIEW DURING LAYING OF JGT & FINISHED CONDITION OF ROAD AFTER 2 YEARS

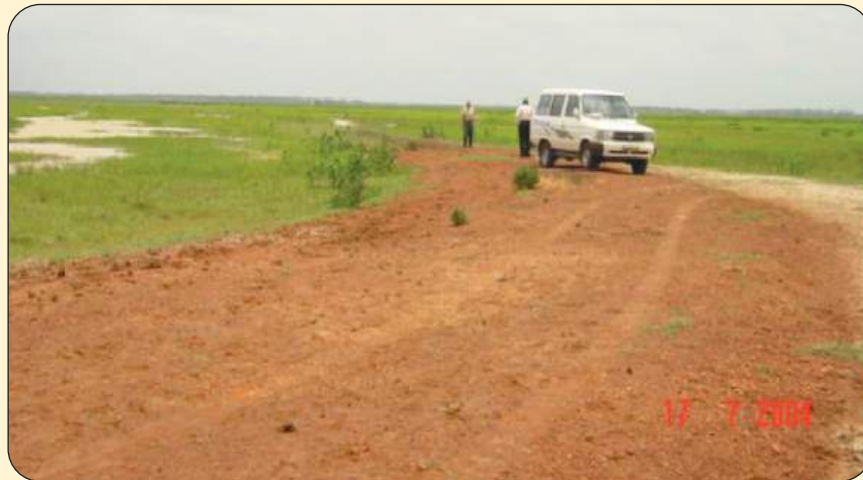
VIEW OF CONDITION OF ROAD BEFORE CONSTRUCTION

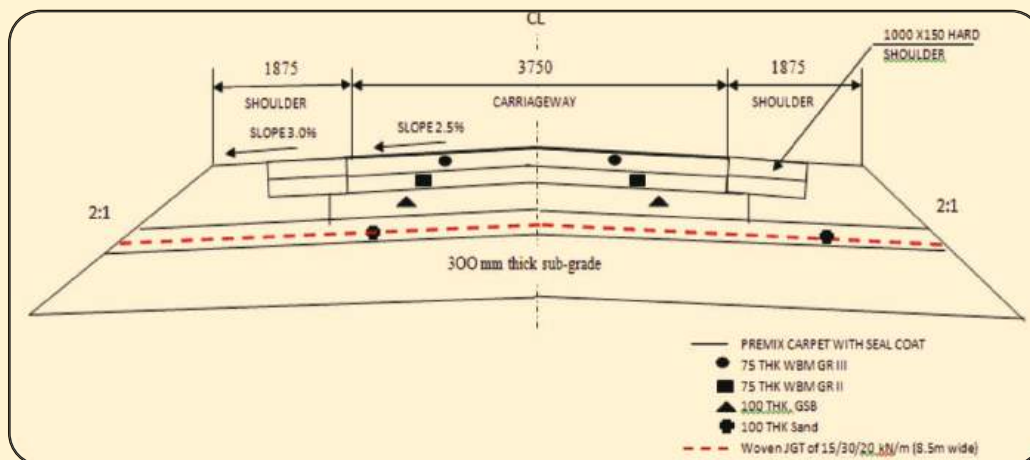
CROSS-SECTIONAL DETAILS OF PAVEMENT WITH JUTE GEOTEXTILE

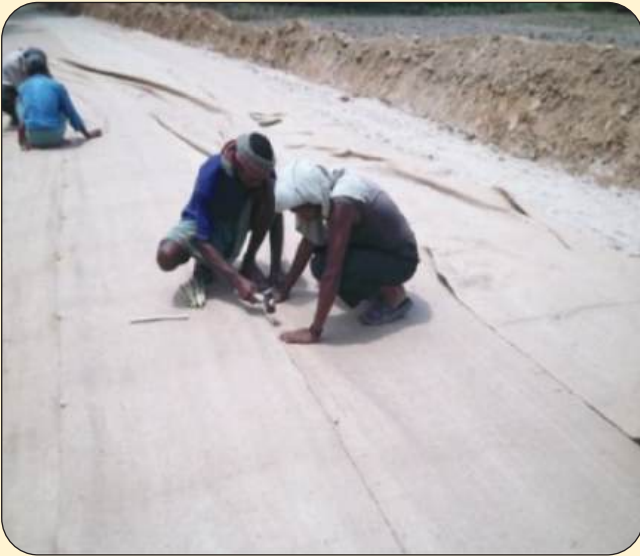
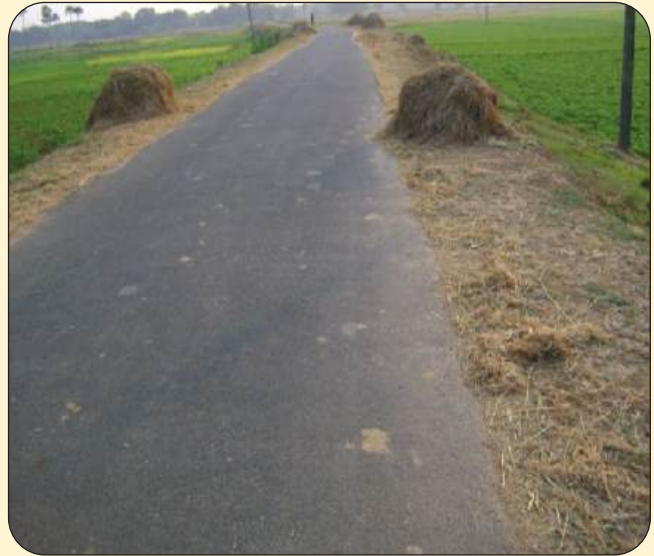
- The blacktop of pavement surface was distress-free during the entire period of performance monitoring
- Shoulders as well as side slope condition were in good shape without any rain-cut or settlement with the use of Open Weave JGT at the slope..

VIEW DURING LAYING OF JGT & FINISHED CONDITION OF ROAD AFTER 31 MONTHS

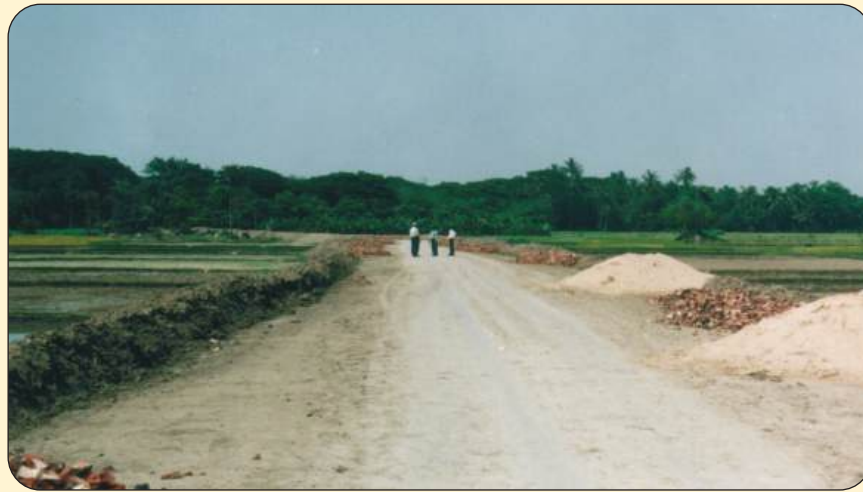
VIEW OF CONDITION OF ROAD BEFORE CONSTRUCTION

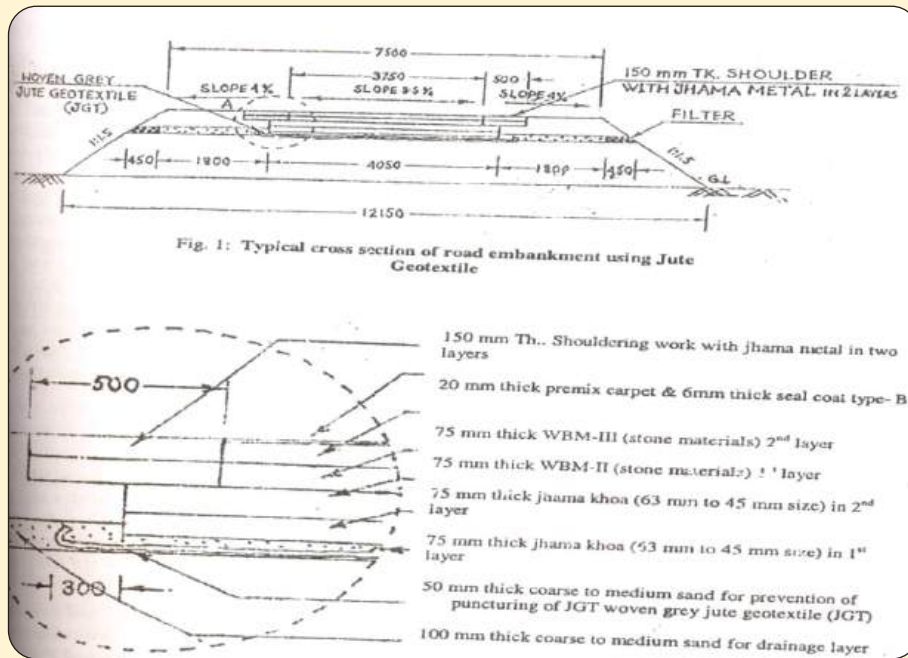
CROSS-SECTIONAL DETAILS OF PAVEMENT WITH JUTE GEOTEXTILE

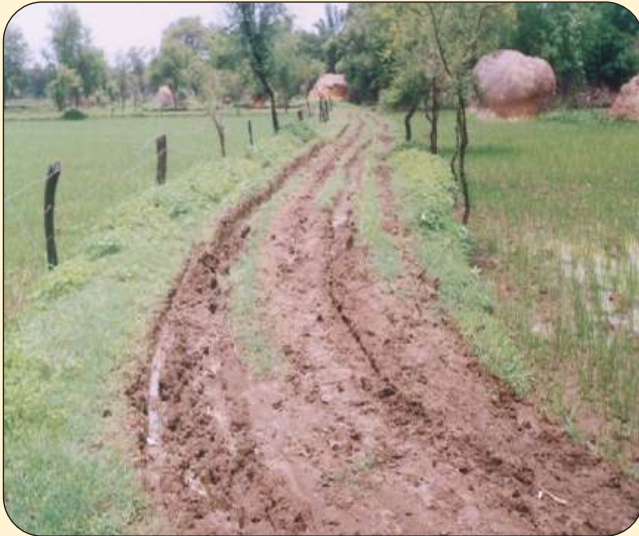
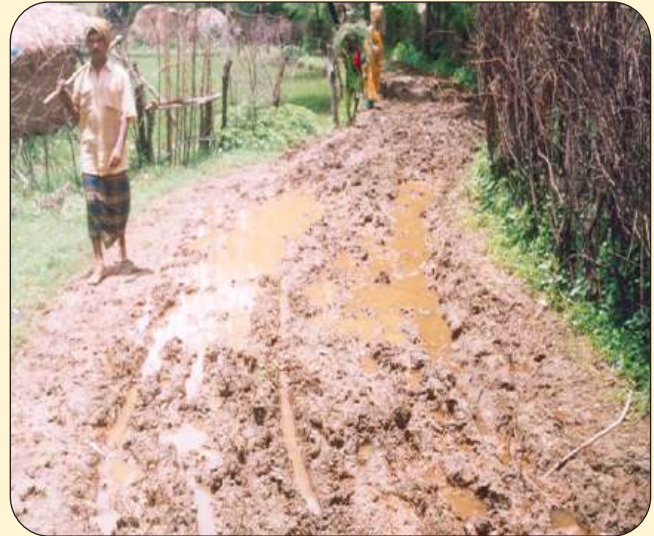
This was an earthen road under PMGSY Pilot project. The soil type was black cotton soil of high compressibility that led to deep ruts under the wheel paths over a major portion of the length. Average annual rainfall observed as 1000 mm. The earthen track transverses through both plain and rolling terrain, water table found to be about 3 to 4 m below GL.

VIEW OF CONDITION OF ROAD BEFORE CONSTRUCTION

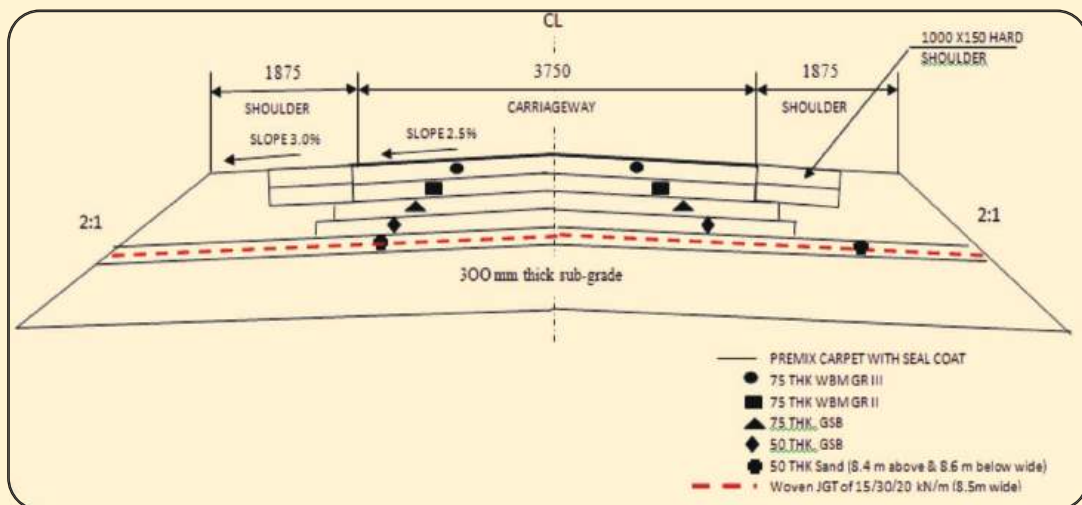
CROSS-SECTIONAL DETAILS OF PAVEMENT WITH JUTE GEOTEXTILE

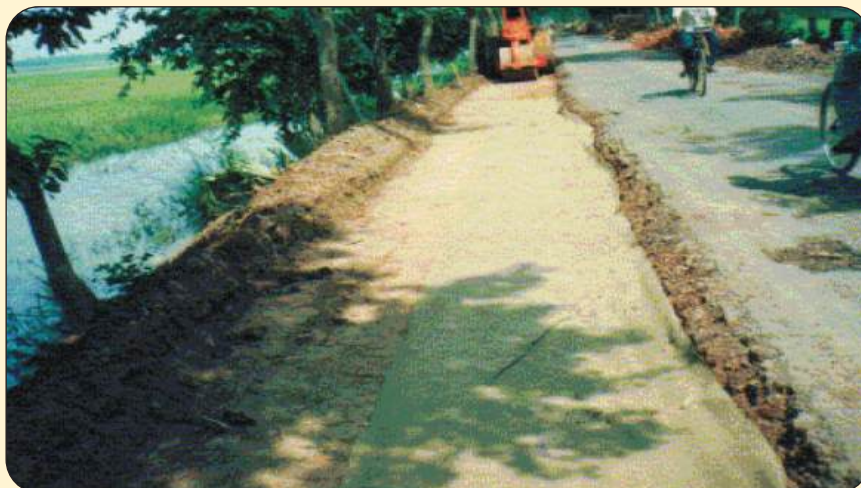
VIEW OF ROAD DURING WIDENING

JGT laid over sub-grade

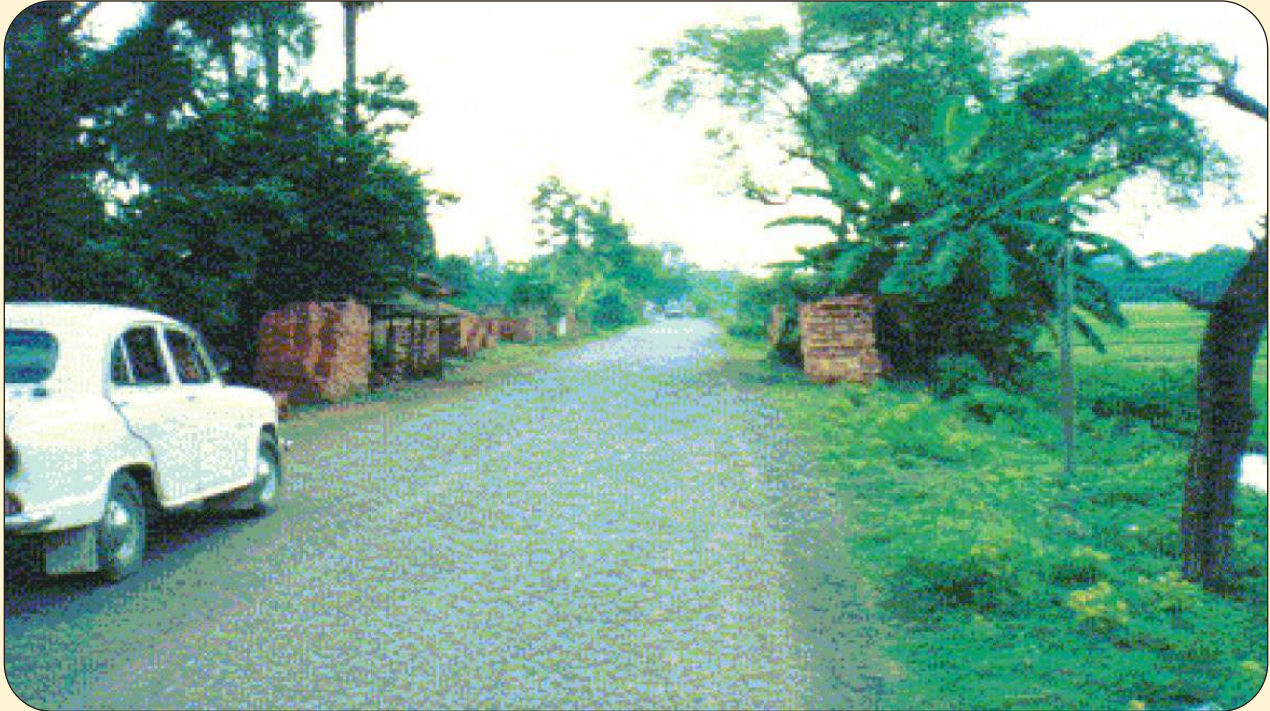
- No distress of road was noticeable
- Riding surface was smooth

VIEW OF FINISHED CONDITION ROAD AFTER 1 YEAR

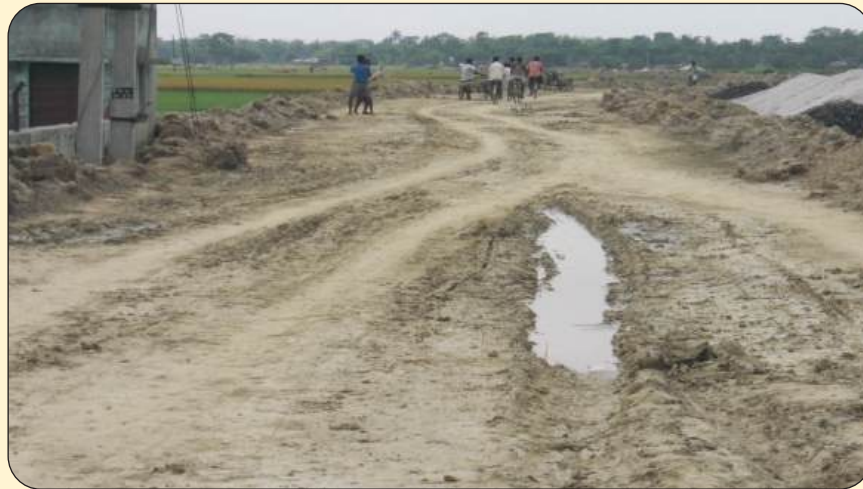
This was an earthen road under PMGSY Pilot project in plain terrain condition. The condition of road was poor almost throughout the stretch. The minimum temperature in the month of January varies from 11.5°C to 18°C and the highest temperature registers as the month of May. Average annual rainfall observed as above 1500mm.

VIEW OF CONDITION OF ROAD BEFORE CONSTRUCTION

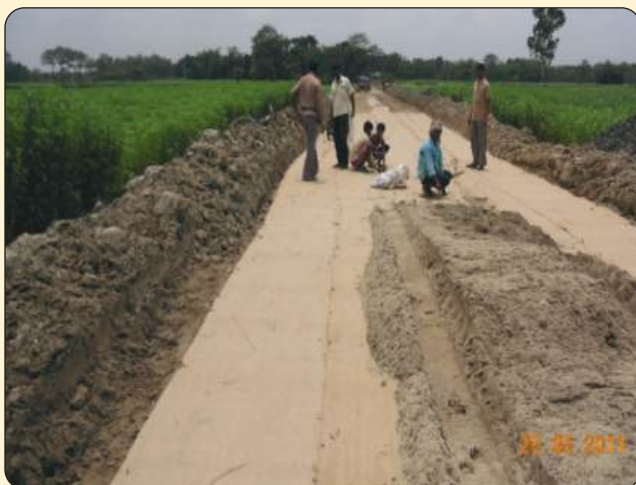
Layer of sand spread over JGT

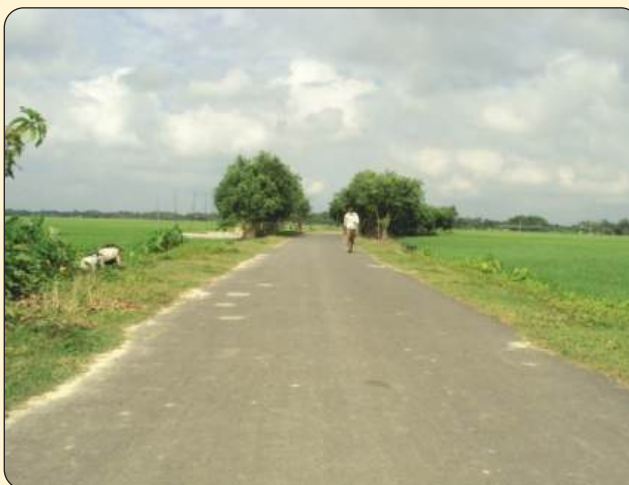
- The riding surface is in good condition with no sign of distresses
- No pot holes or rutting observed.
- Shoulders as well as side slope condition is in good condition without any rain-cuts or settlement at the slope.

Finished Condition of road after 3 years (2015)

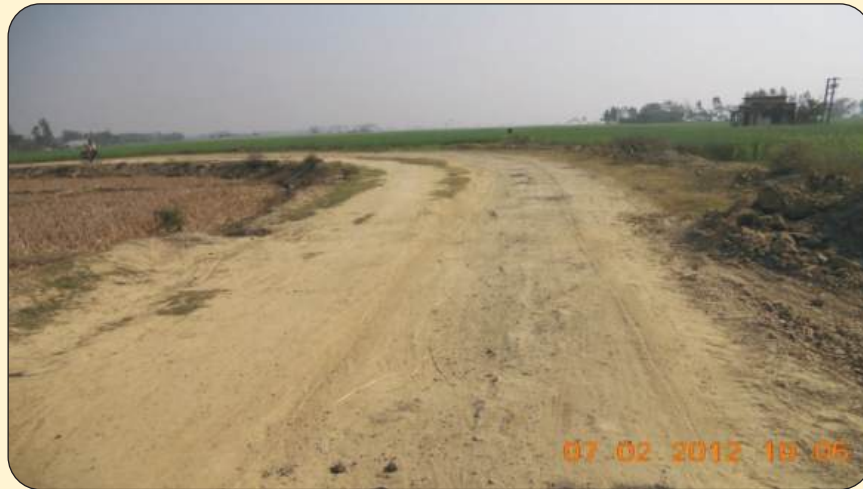
This was an earthen road under PMGSY Pilot project in plain terrain condition. The condition of road was poor almost throughout the stretch. The minimum temperature in the month of January varies from 11.5°C to 18°C and the highest temperature registers as the month of May. Average annual rainfall observed as above 1500 mm.

VIEW OF CONDITION OF ROAD BEFORE CONSTRUCTION

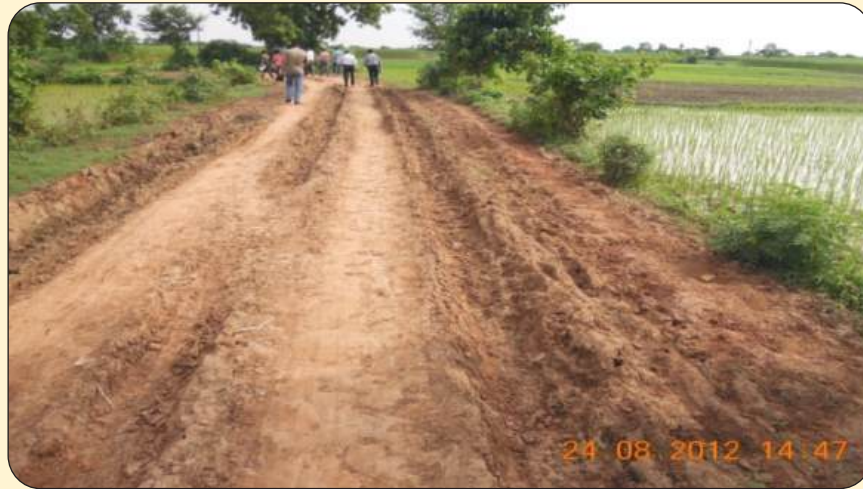
This was an earthen road under PMGSY Pilot project in plain terrain. The condition of road was poor almost throughout the stretch. The minimum temperature in the month of January varies from 7.8°C to 15.5°C and the highest temperature registers as the month of May about 38°C. Average annual rainfall observed as above 1593mm.

VIEW OF CONDITION OF ROAD BEFORE CONSTRUCTION

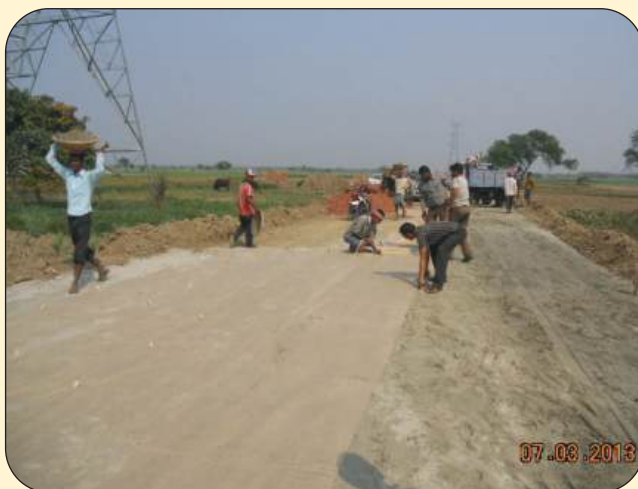
JGT laid over sand

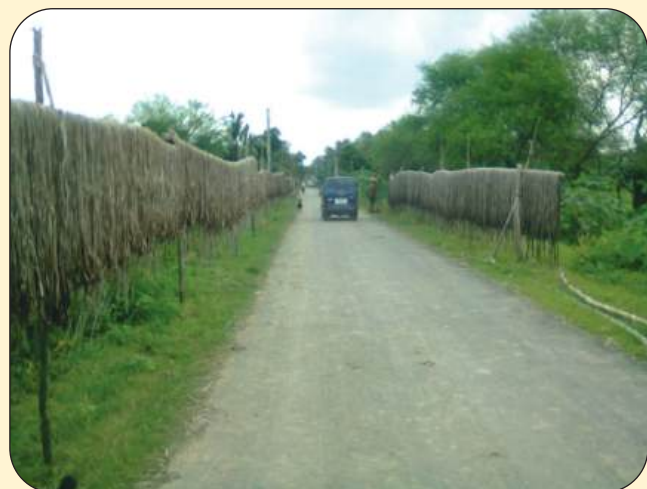
- The riding surface is in good condition with no sign of distresses
- No pot holes or rutting observed.
- Shoulders as well as side slope condition is in good condition without any rain-cuts or settlement at the slope.

Finished Condition of road after 1 year (2015)

Note : The movement of heavy loaded truck of about 25 – 30 tonnes carrying sand, bricks on this road has increased immensely to about 30-35 passes in a day.

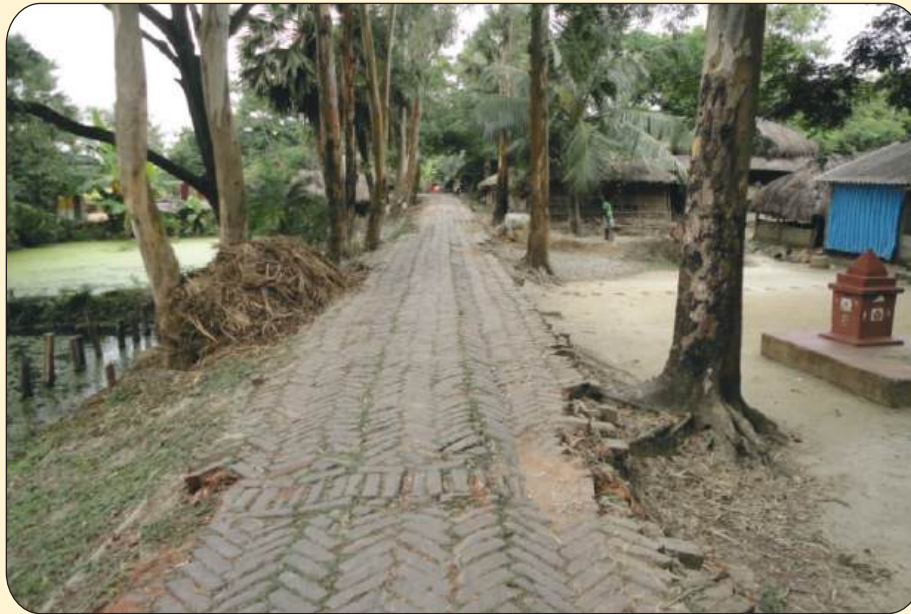
This was an earthen road with brick pitching under PMGSY Pilot project in plain terrain. The minimum temperature in the month of January varies from 10°C to 15°C and the highest temperature registers as the month of May about 42°C. Average annual rainfall observed as above 1500 mm.

VIEW OF CONDITION OF ROAD BEFORE CONSTRUCTION

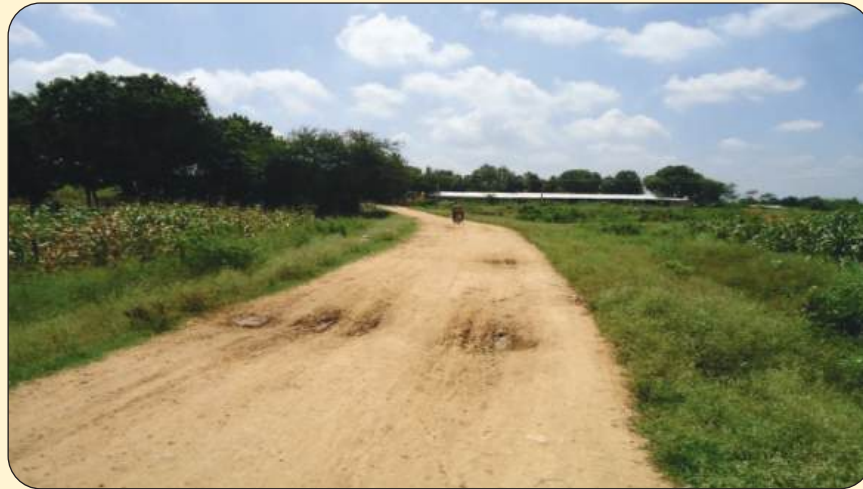
This was an earthen road under PMGSY Pilot project in plain terrain. Average annual rainfall observed as above 1300 mm.

VIEW OF CONDITION OF ROAD BEFORE CONSTRUCTION

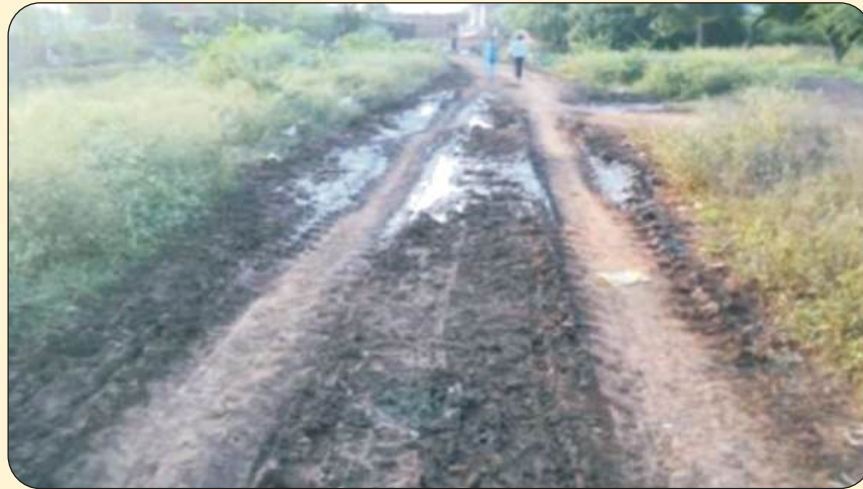
This was an earthen road under PMGSY Pilot project in rolling terrain. Average annual rainfall observed as above 1300 mm.

VIEW OF CONDITION OF ROAD BEFORE CONSTRUCTION

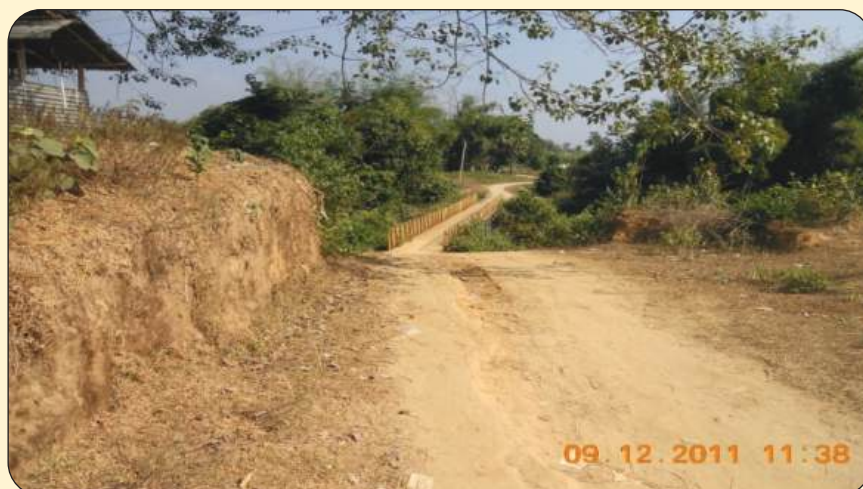
This was an earthen road under PMGSY Pilot project in rolling terrain. Average annual rainfall observed as above 2000 mm.

VIEW OF CONDITION OF ROAD BEFORE CONSTRUCTION

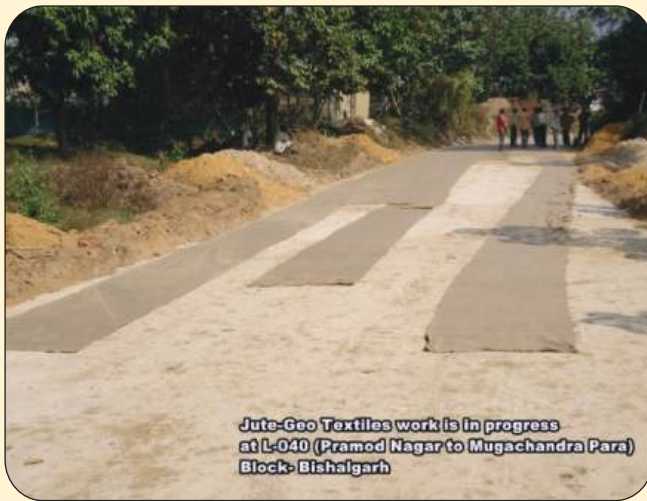
Laying of JGT

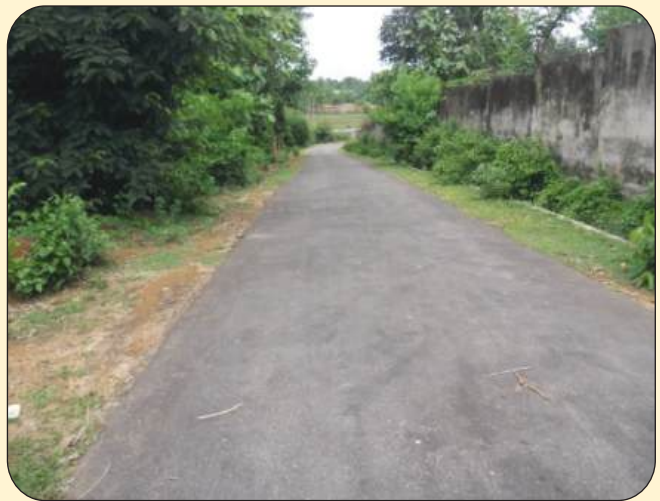
- The riding surface is in good condition with no sign of distresses
- No pot holes or rutting observed.
- Shoulders as well as side slope condition is in good condition without any rain-cuts or settlement at the slope.

Finished Condition of road after 2 years (2015)

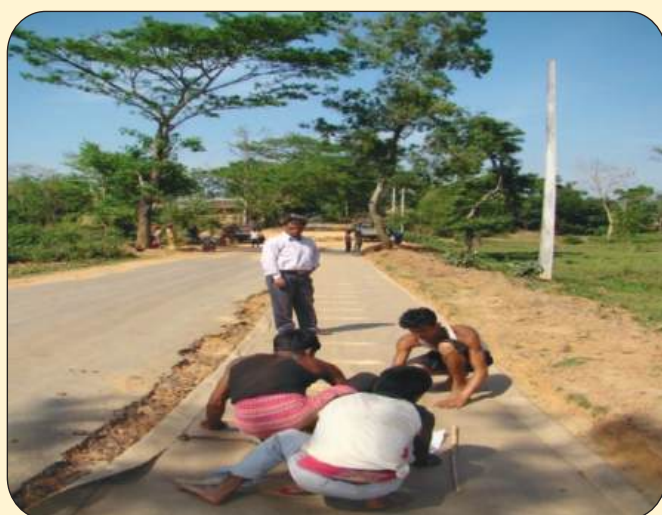
Laying of JGT in widened portion

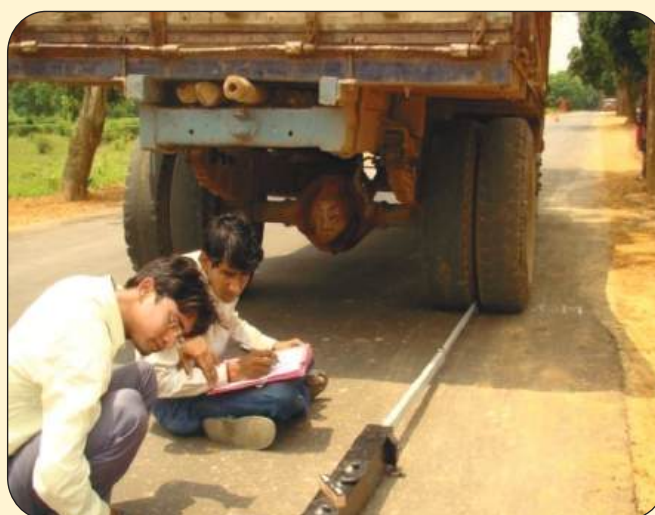
Finished Condition of road after 2 years (2010)

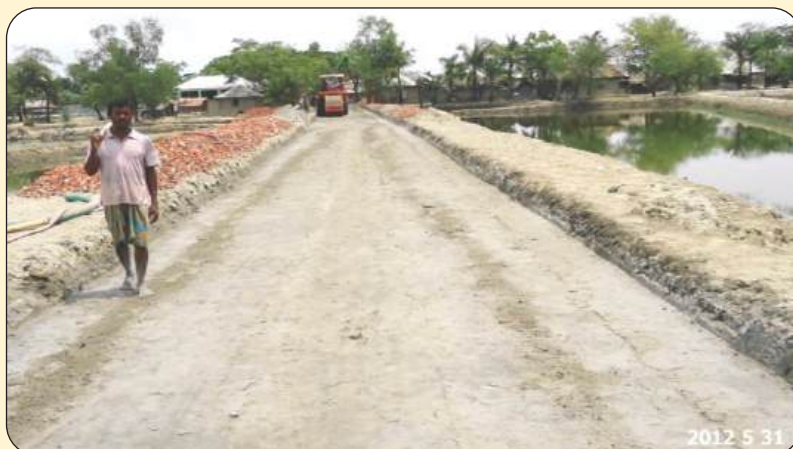
VIEW OF CONDITION OF ROAD BEFORE CONSTRUCTION

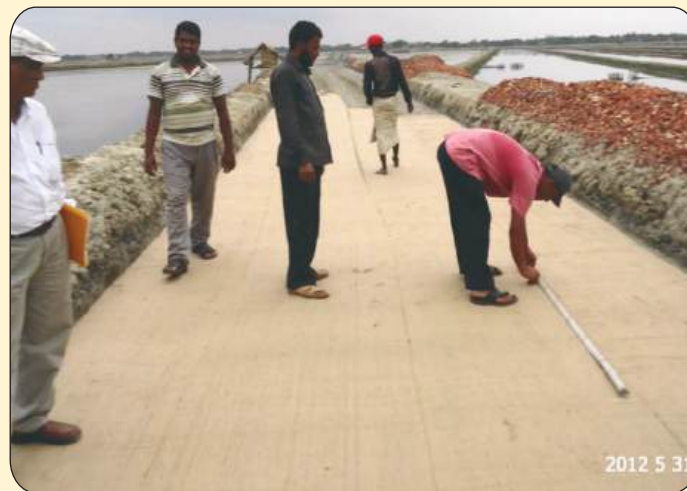
VIEW OF LAYING OF JGT & FINISHED CONDITION ROAD

Construction Started in July, 2012

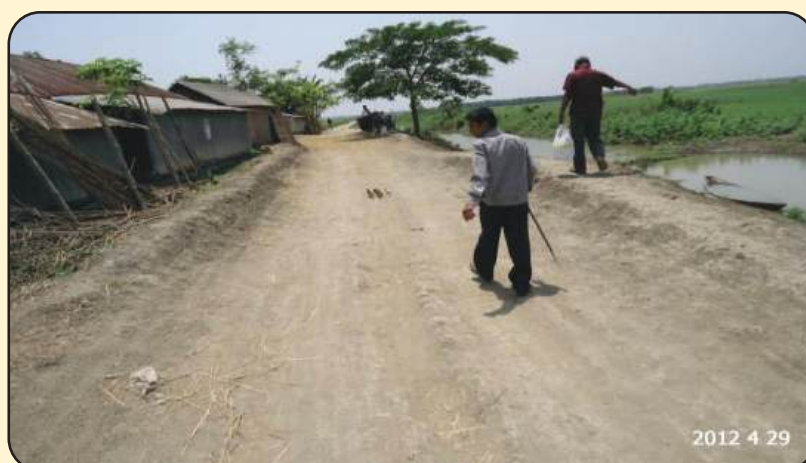
VIEW OF CONDITION OF ROAD BEFORE CONSTRUCTION

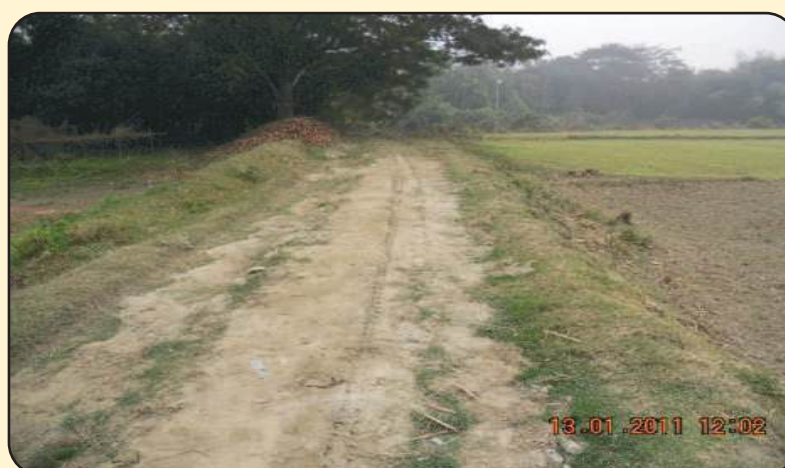
VIEW OF CONDITION OF ROAD BEFORE CONSTRUCTION

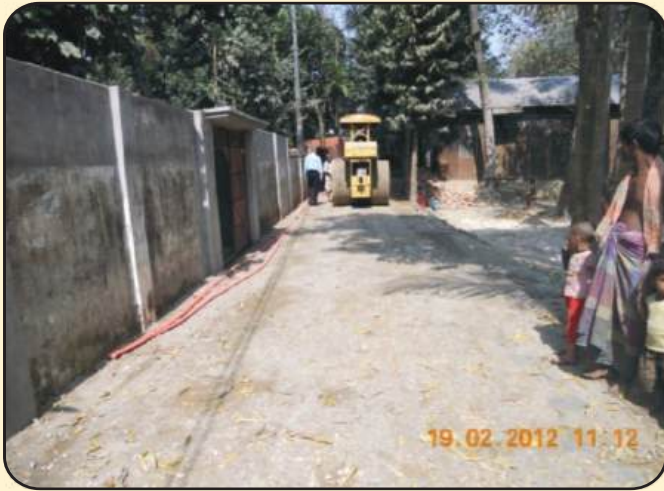
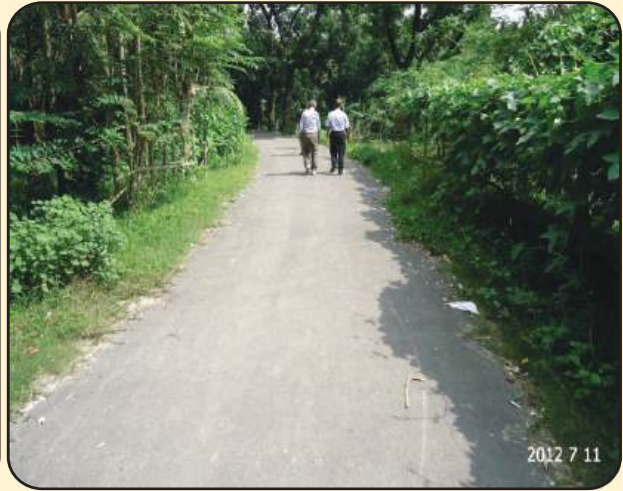
VIEW OF DURING CONSTRUCTION & FINISHED CONDITION ROAD

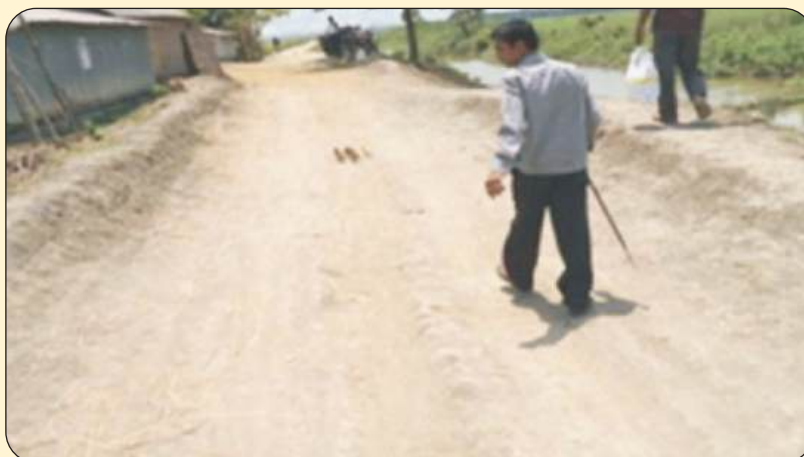
VIEW OF CONDITION OF ROAD BEFORE CONSTRUCTION

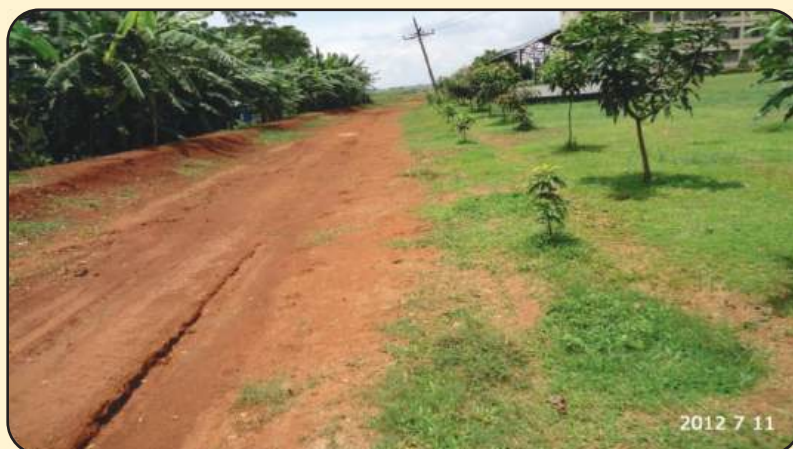
VIEW OF CONDITION OF ROAD BEFORE CONSTRUCTION

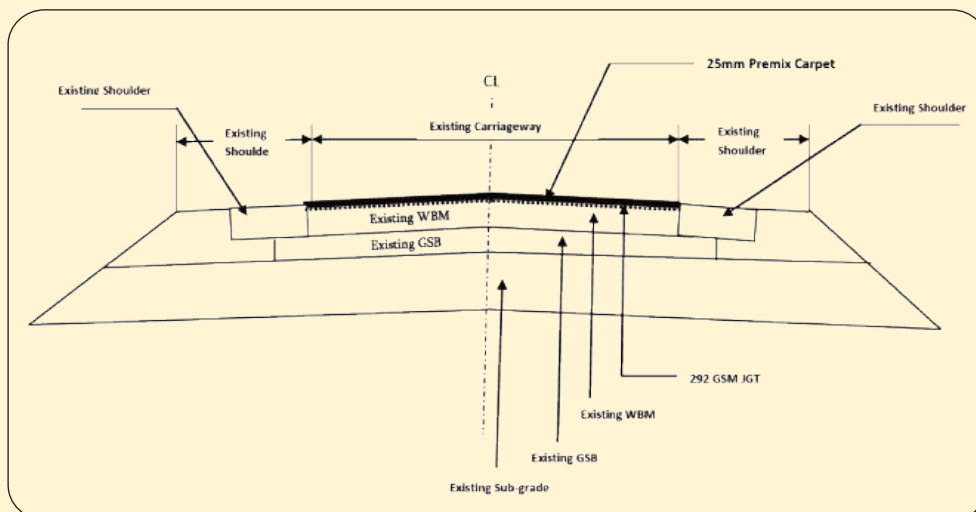
CROSS-SECTIONAL DETAILS OF PAVEMENT WITH JUTE GEOTEXTILE

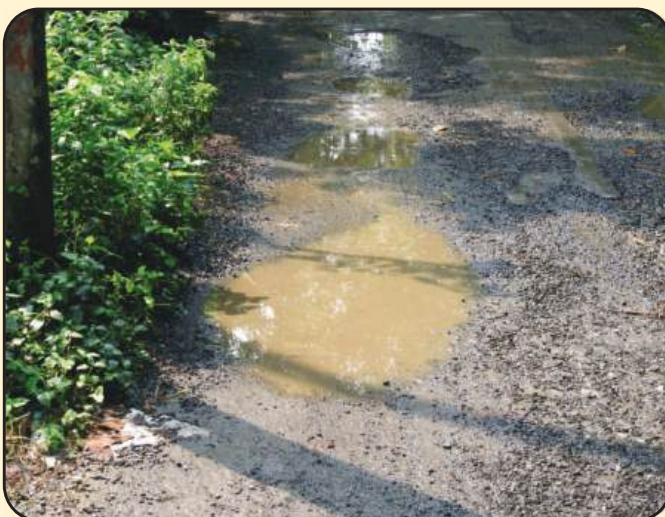
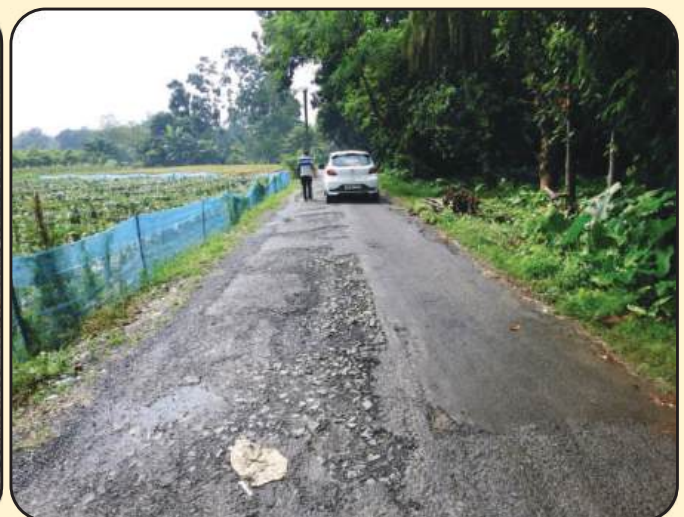
VIEW OF CONDITION OF ROAD BEFORE CONSTRUCTION

21 Prework and postwork observations were conducted by West Bengal State Rural Development Agency, Govt. of West Bengal

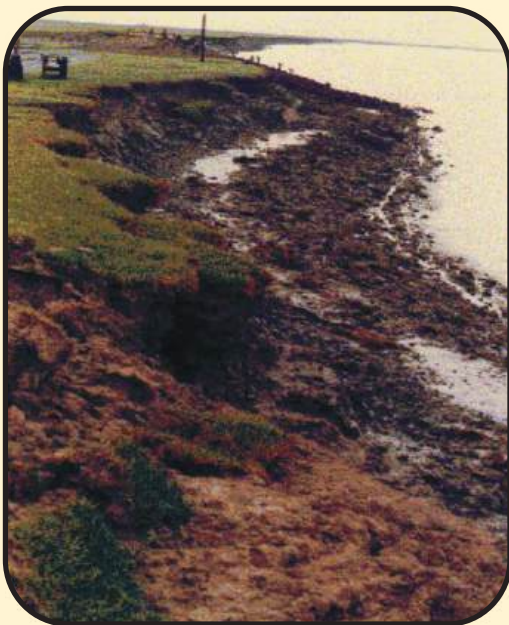
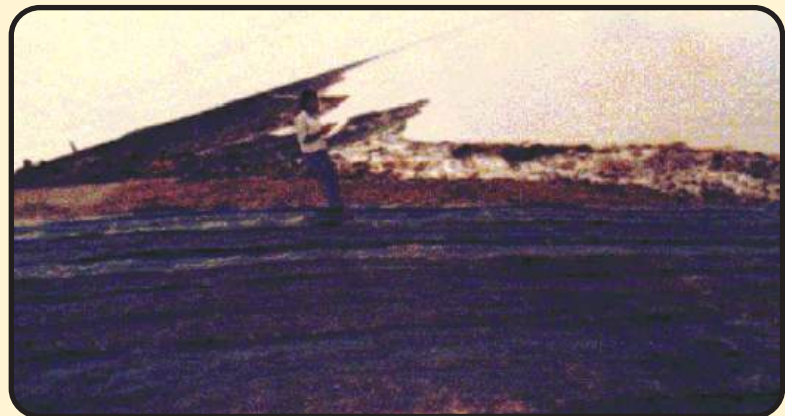
VIEW DURING LAYING OF JGT

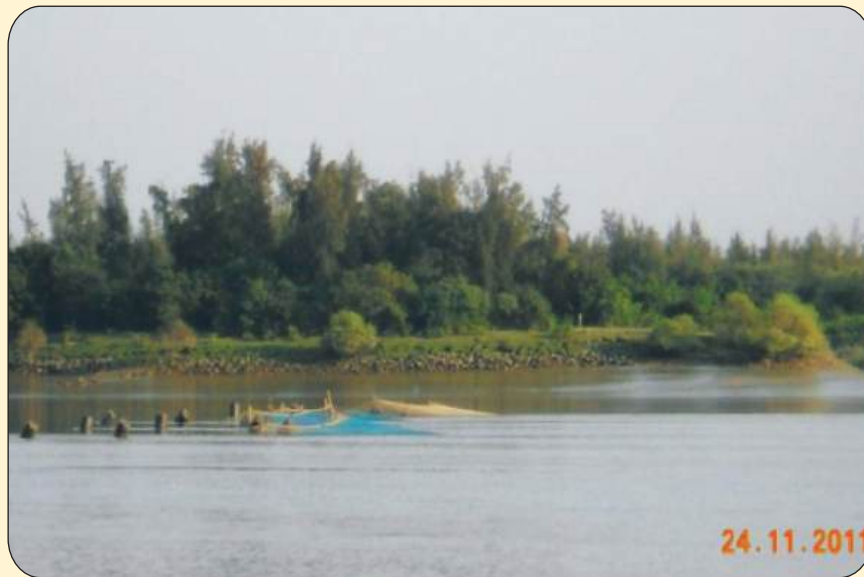
- Entire stretch of JGT treated portion is in good shape with no distresses observed even after 2 decades.
- Even in high tidal fluctuations and high salinity, JGT worked satisfactorily.
- Submerged granular spurs were constructed at some places for neutralizing effects of eddies at the bank toe.
- The growth of mangrove seedlings planted through JGT could not rise above the thickness of sediment deposited on the bank implying that the rate of growth of mangrove seedlings was less than siltation rate at the particular location.

VIEW OF CONDITION RIVERBANK AFTER TWO DECADES OF JGT APPLICATION

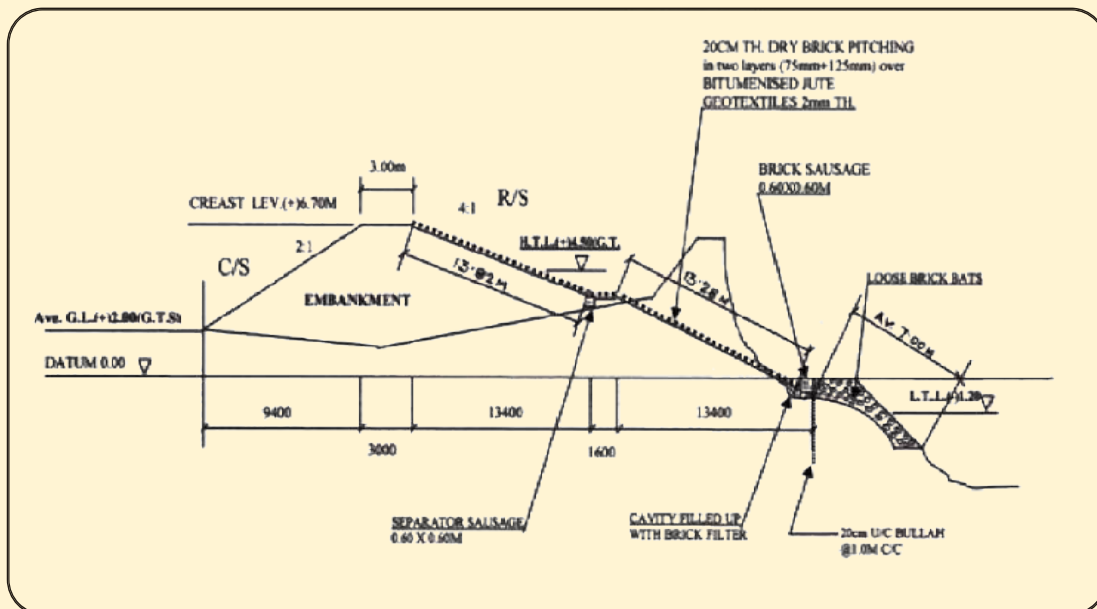
CROSS-SECTIONAL DETAILS OF PROTECTION WORK WITH JGT

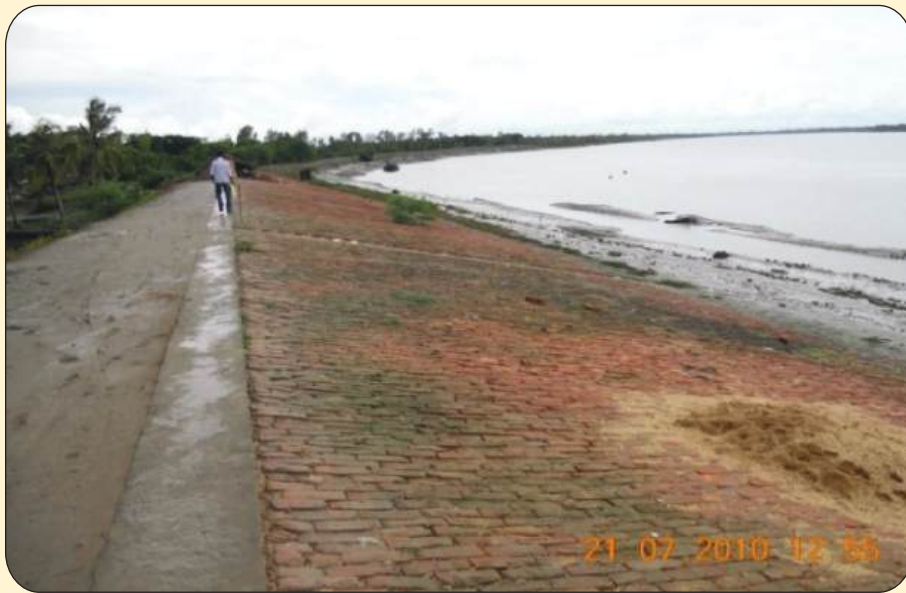
- Entire portion of JGT treated portion of bank is stabilized and in good shape with no distresses observed even after two and half years.
- Even in high tidal fluctuations and high salinity JGT worked satisfactorily in the eroded bank section treated with JGT.

VIEW OF CONDITION RIVERBANK AFTER TWO AND HALF YEARS OF JGT APPLICATION
