CASE STUDIES WITH JUTE GEOTEXTILES (JGT)

NATIONAL JUTE BOARD

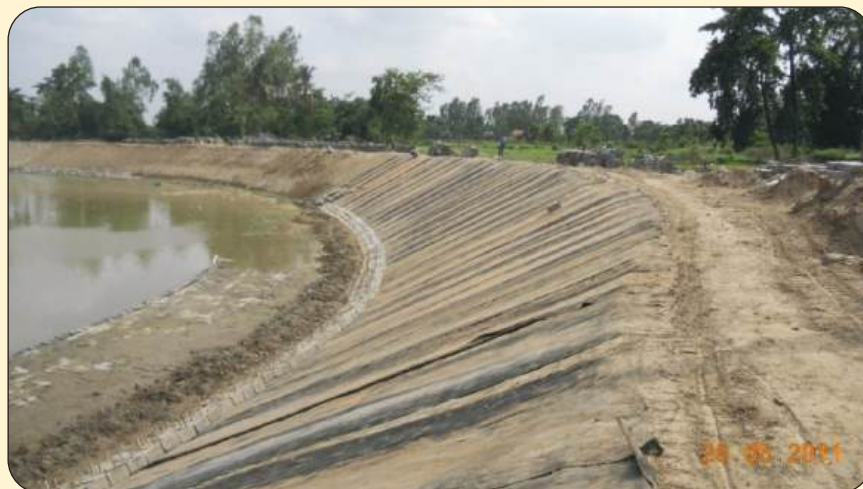
VIEW DURING LAYING OF JGT

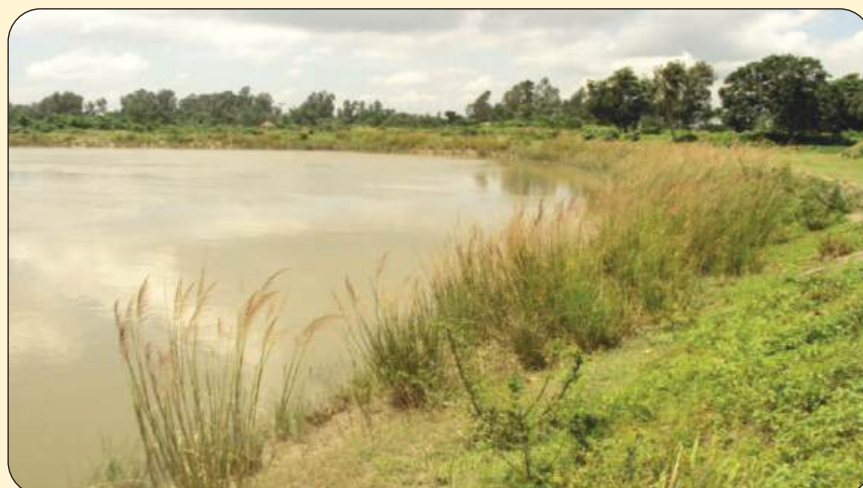
- Entire stretch of JGT treated portion is in good shape with no distresses observed even after more than 3 years.
- Dense growth of vegetation is observed in entire stretch of bank treated with JGT.
- Even in concavity portion of bank where the impact of flood water is higher, JGT worked satisfactorily.

VIEW OF CONDITION RIVER BANK AFTER THREE YEARS OF JGT APPLICATION

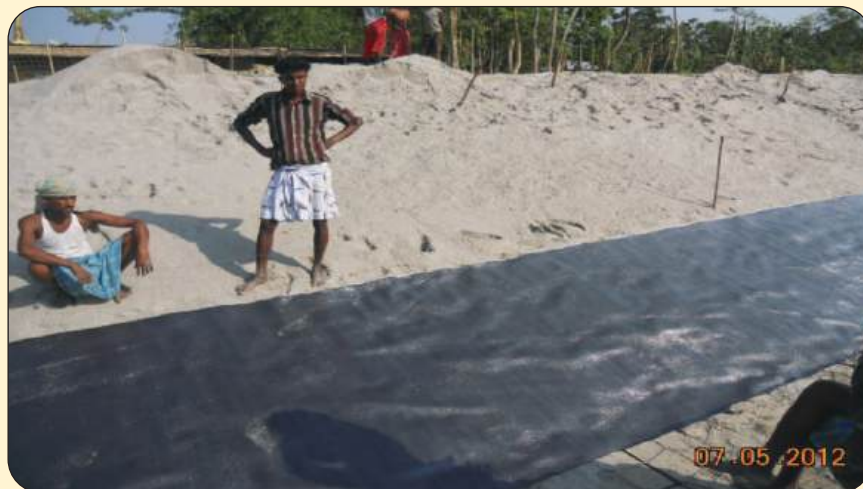
VIEW DURING LAYING OF JGT

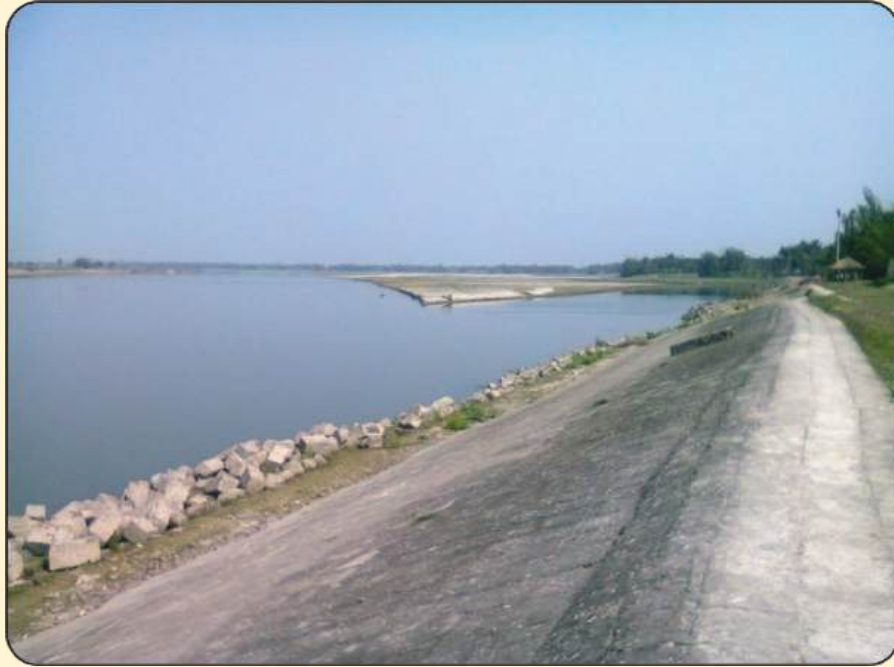
- Entire stretch of JGT treated portion is in good shape with no distresses observed even after 3 years.
- Even in such high discharge of five rivers together, bank treated with JGT worked satisfactorily.

VIEW OF CONDITION RIVER BANK AFTER THREE YEARS OF JGT APPLICATION

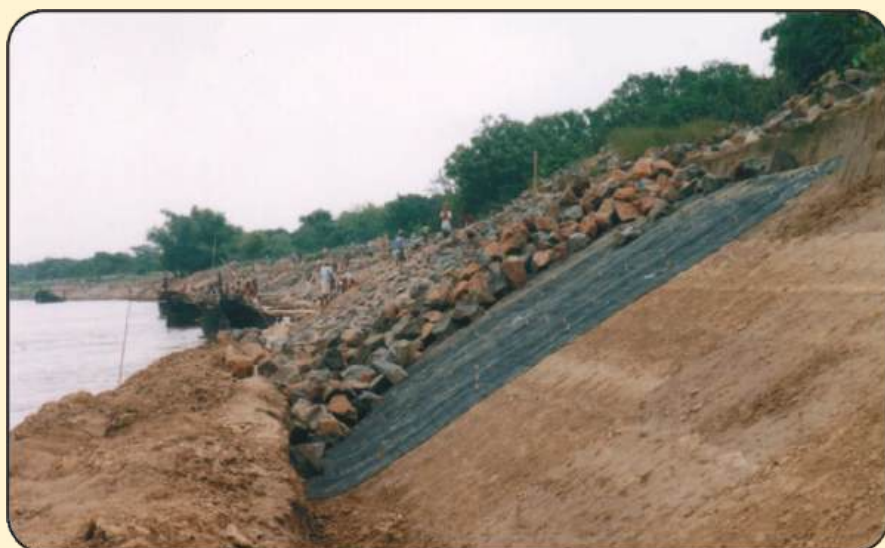
VIEW DURING LAYING OF JGT

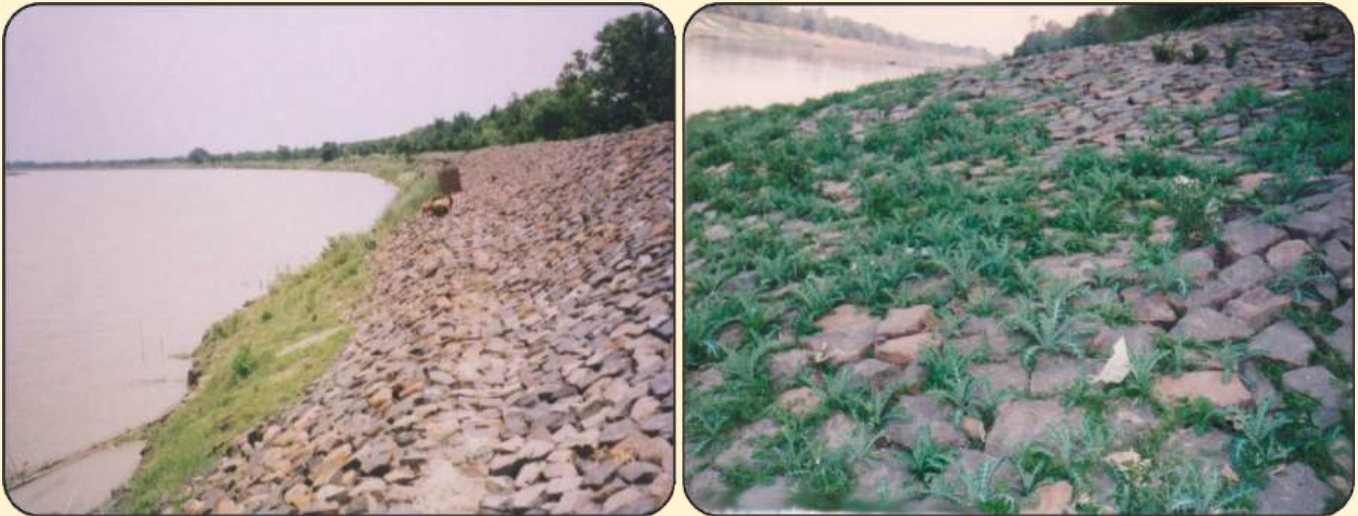
- Entire stretch of JGT treated portion is in good shape with no distresses observed even after more than 3 years.
- Dense growth of vegetation is observed in entire stretch of bank treated with JGT.
- Even in concavity portion of bank where the impact of flood water is higher, JGT worked satisfactorily.
- Based on excellent performance of JGT, I & WD Deptt. has undertaken the bank protection work with JGT in other stretches of the same river.

VIEW OF CONDITION RIVER BANK AFTER THREE YEARS OF JGT APPLICATION

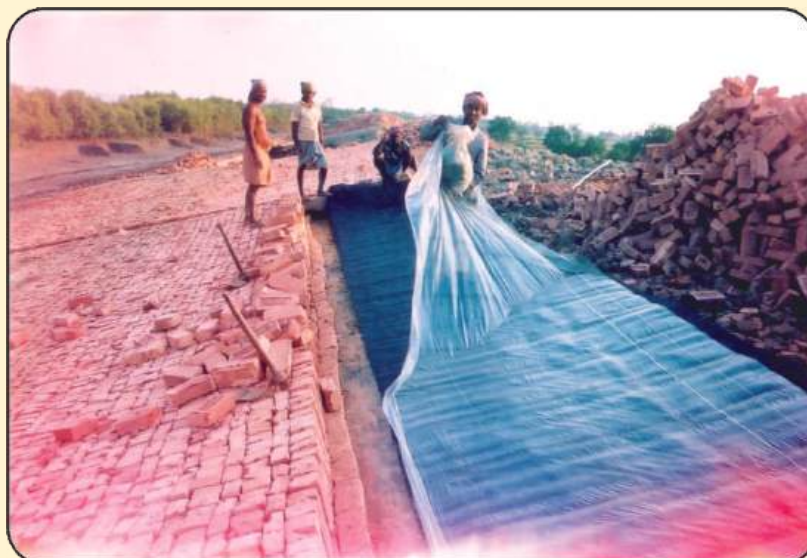
VIEW DURING LAYING OF JGT

- Entire stretch of JGT treated portion is in good shape with no distresses observed even after more than 3 years.
- Dense growth of vegetation is observed in entire stretch of bank treated with JGT.
- JGT have served its purpose as an effective filter material for river bank erosion control.

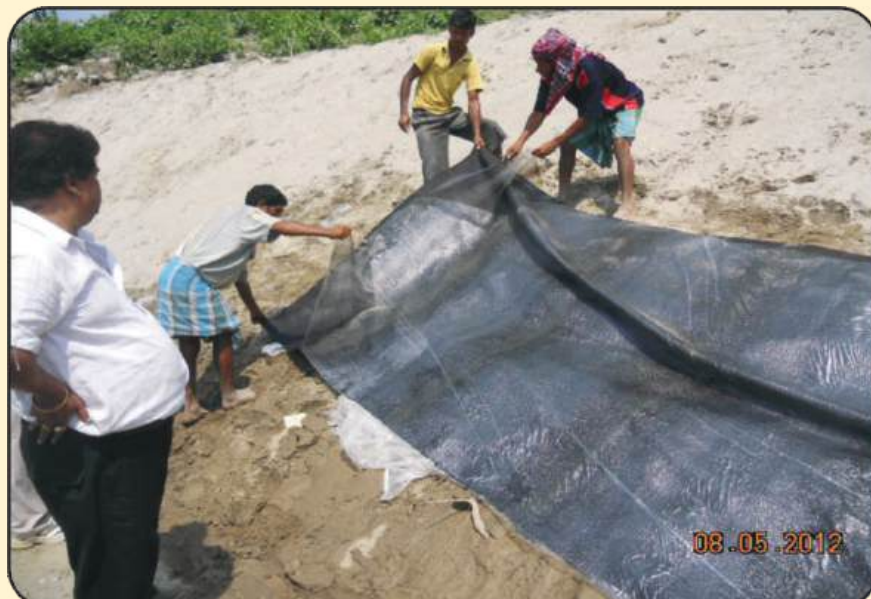
VIEW DURING LAYING OF JGT

- Entire stretch of JGT treated portion is in good shape with no distresses observed even after more than 3 years.
- Dense growth of vegetation is observed in entire stretch of bank treated with JGT.
- JGT have served its purpose as an effective filter material for river bank erosion control.

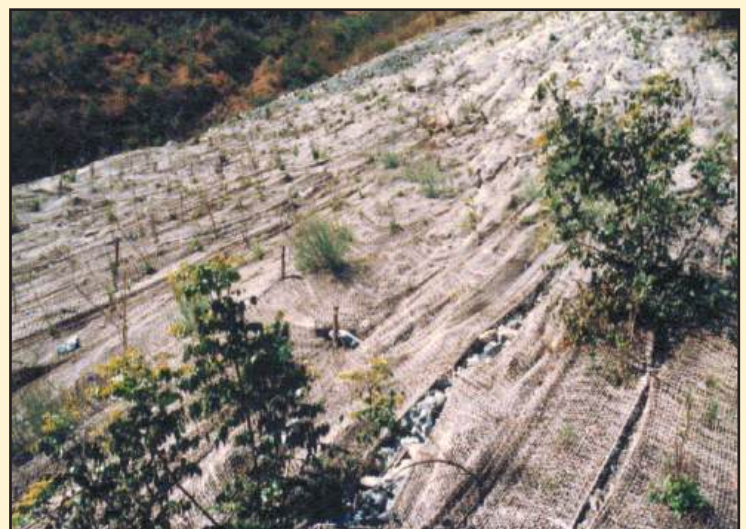
VIEW AFTER LAYING OF JGT & SPROUTING OF SEEDLINGS THROUGH JGT

(a) JGT degraded in about 2 years, by then vegetation cover had established itself providing good anchorage to soil.

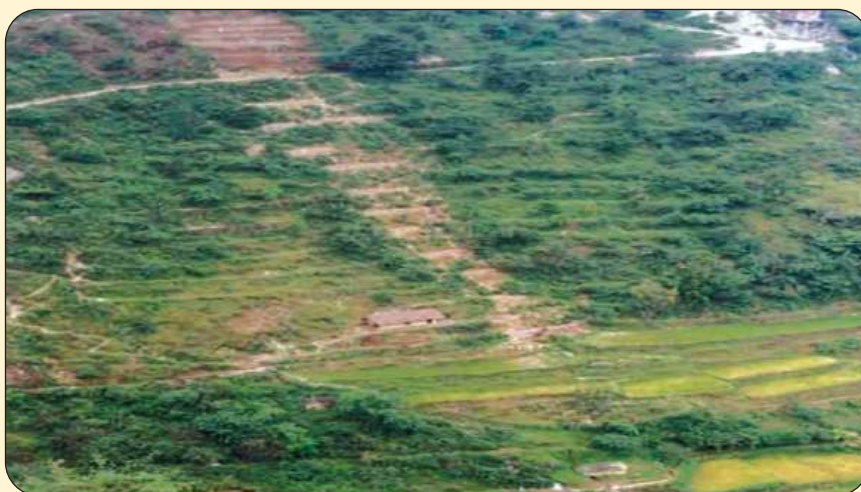
VIEW OF STABILIZED MINE SPOIL TREATED WITH JGT AFTER 9 YEARS

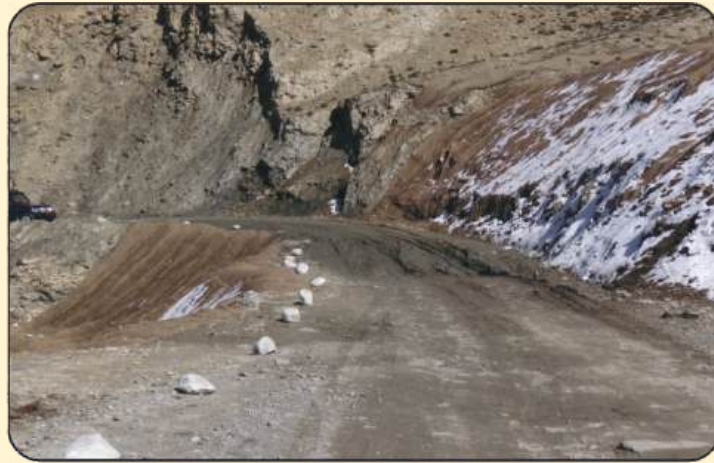
VIEW AFTER LAYING OF JGT & FORMATION OF SNOW OVER JGT

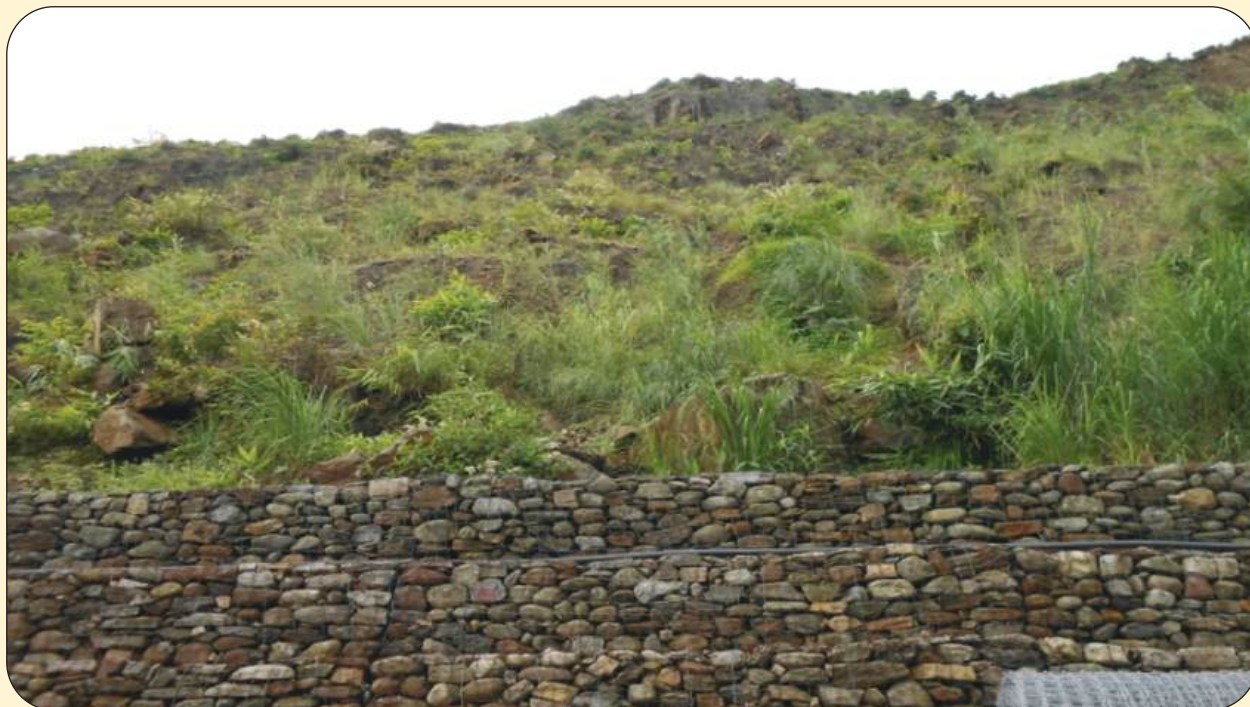
VIEW AFTER SLOPE STABILIZATION AND GROWTH OF VEGETATION

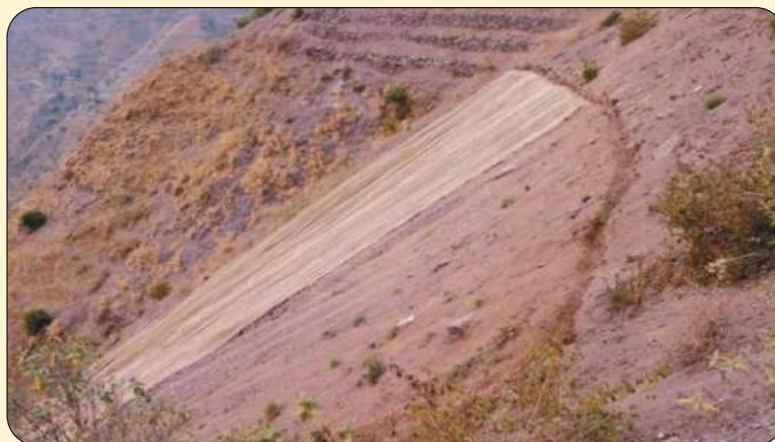
VIEW AFTER LAYING OF JGT

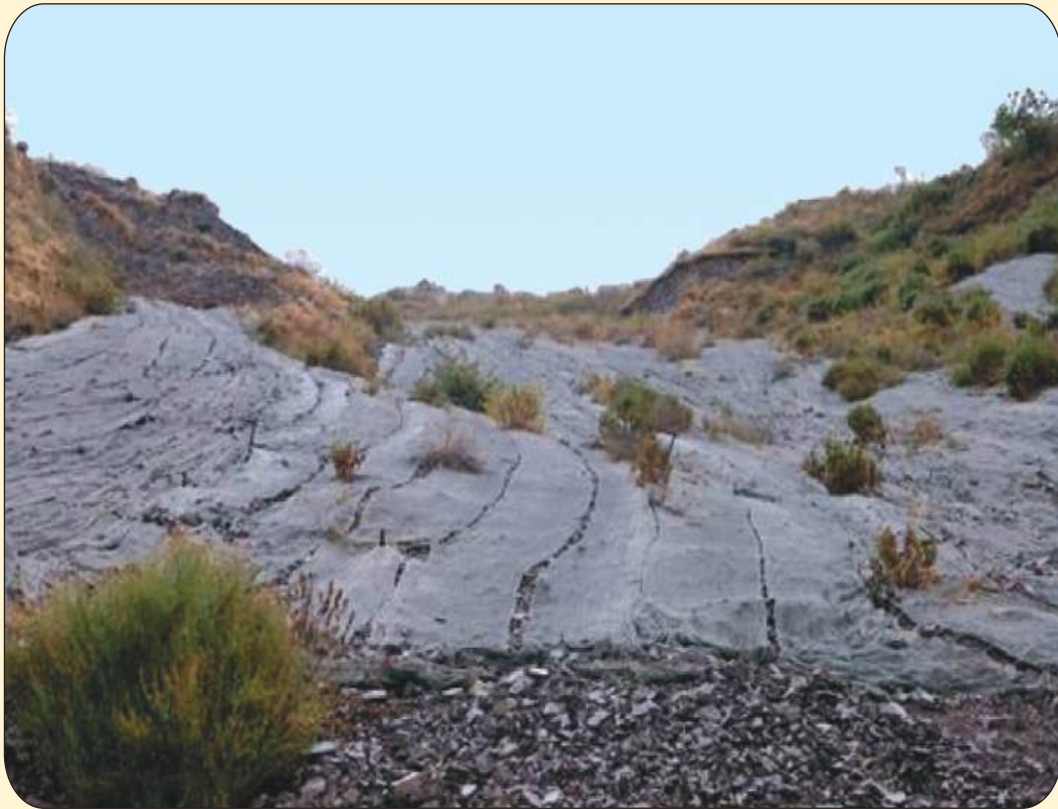
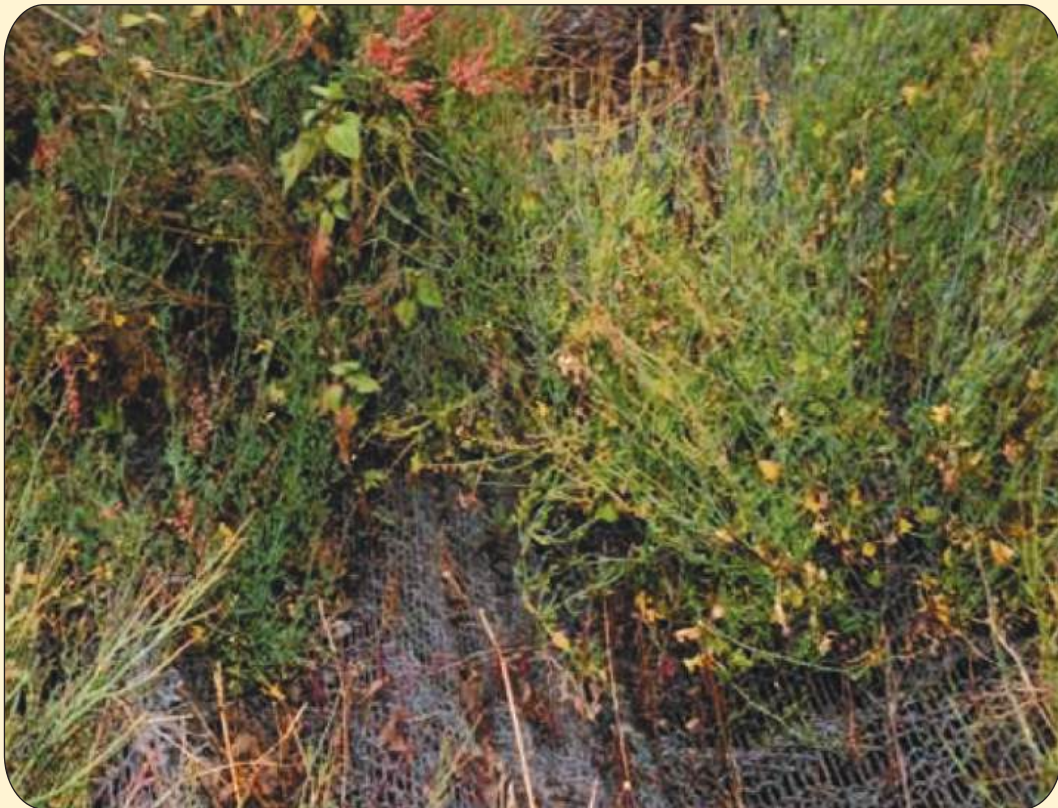
VIEW OF STABILIZED SLOPE & GROWTH OF VEGETATION AFTER 1 YEAR
